Manhole Inspection Summary

Manhole # S15GG1016MH

Insp Date: **3/1/07 9:30 AM**

Location Address: **4011 DERBY MANOR DR**

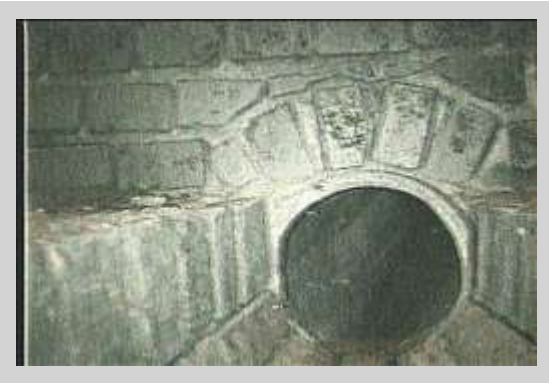
8 in. Circular Gravity Sewer Pipe Out @ 12 O'Clock

Rod and Bar (Angled)

Pipe Material: **Clay** ☐ Pipe Lined

Infiltration: **None** Pipe Seal Cond: **Unknown**
